Atmospheric Type Vacuum Breakers used with Shampoo Bowls for the Hair Salon Industry

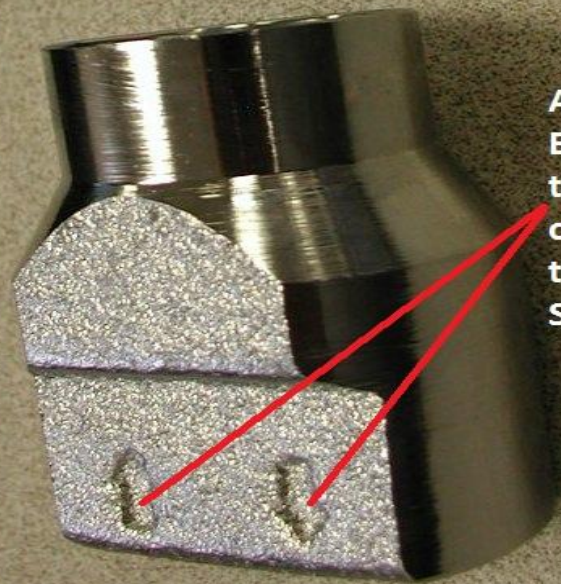
Removable Cap attaches to the top of the Vacuum Breaker Body. Make sure this Cap is fully hand tightened.

Plastic Seal with Red Silicone Rubber Washer.

Arrows on Vacuum Breaker Body. Up is the inlet for the faucet connection. Down is the outlet for the Sprayhose

1. The top cap of an Atmospheric Type Vacuum Breaker may be loose. **(See attached photo)**

Solution: Check that the cap is fully hand tightened. Use a glove or cloth to grip the cap when tightening to protect your hands from cuts.

Solution: Make sure the water supply and sprayhose connections are installed correctly. The Vacuum Breaker has two arrows molded into the side of the body indicating where to attach these hose connections. The water supply from the faucet should be connected to the side with the arrow pointing upward. The sprayhose or outlet should be connected to the side with the arrow pointing downward. If these connections are reversed, there will be constant leaking when the faucet is turned on. In addition, assemble the Vacuum Breaker/Receiver Cap Assembly before installing on the bowl. Make sure to use Teflon tape on the threads, (do not use pipe sealant) and that the pipes are securely attached to Vacuum Breaker Head. Use vise grip type pliers if necessary to insure a tight connection. **(See attached photo)**
