Clean Jet MAX Cap Bushing Replacement

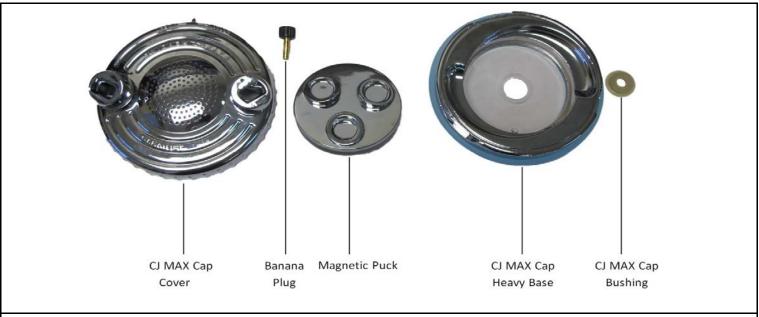
- 1 Pull CJ MAX Cap from the pedicure bowl
- 2 Remove Banana Plug by simply pulling it from the cap
- 3 Turn the CJ MAX Cap cover counter-clockwise (below the silver tab and banana plug hole are arrows)
- 4 Remove magnetic puck and turn the CJ MAX Cap heavy base upside down on a flat, sturdy surface
